UNITED STATES ENVIRONMENTAL PROTECTION AGENCY

Re: **Request for Information**
Docket No. CWA-IR-16-033
EPA Audit Report – July 7-9, 2015
Town of Southampton Municipal Separate Storm Sewer System
SPDES No. NYR20A454

Water Compliance Inspection Report

Southampton MS4 Audit Photograph Log

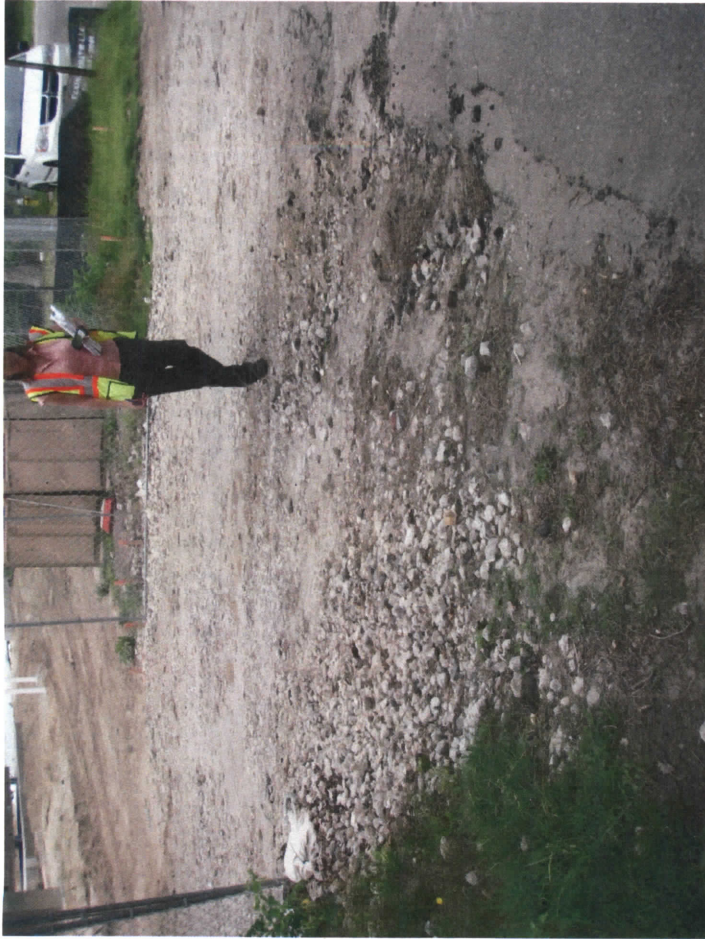
P7080002: Construction entrance noted as in need of refreshing at East End Hospice Construction Site

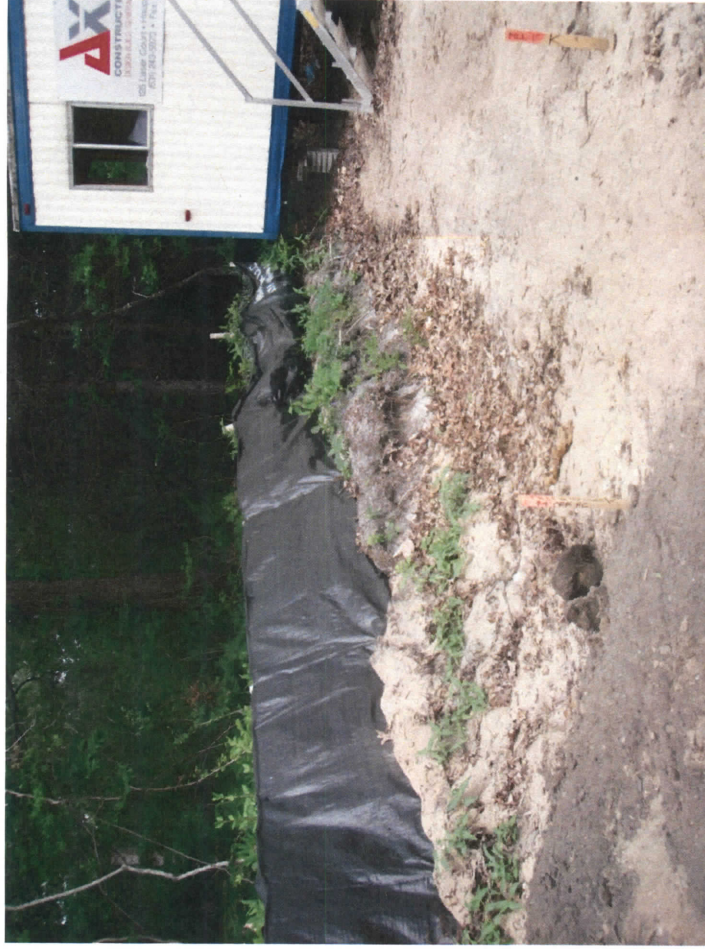
P7080003 – Silt fencing near construction trailer at East End Hospice construction site in need of minor maintenance

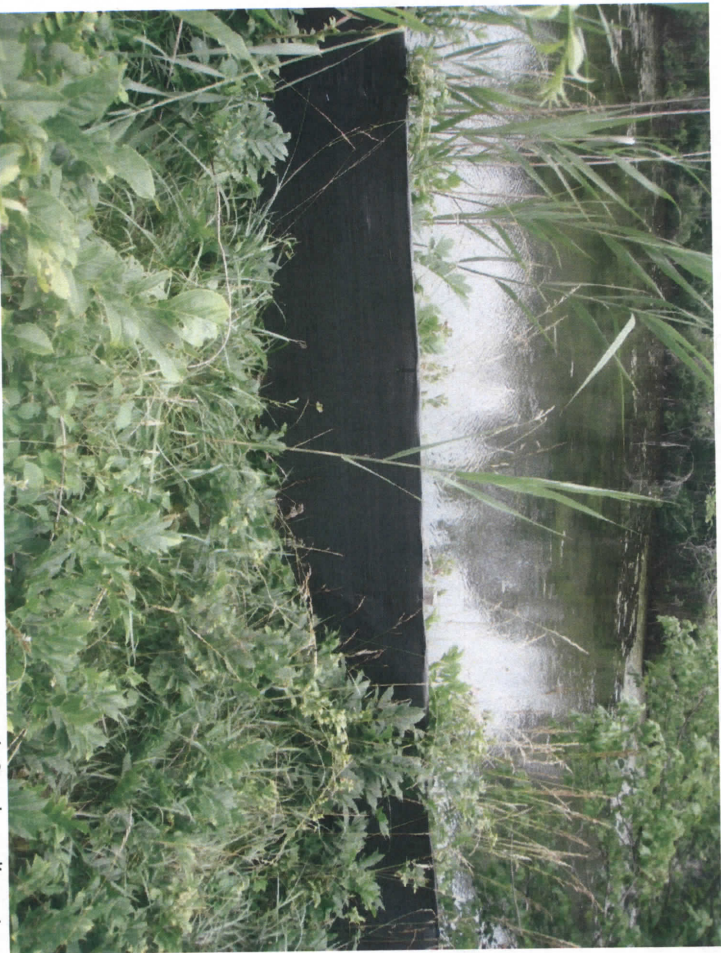
P7080004: Vegetative buffer next to silt fencing adjacent to Aspatuck Creek; sediment build-up or movement to waterway was not observed

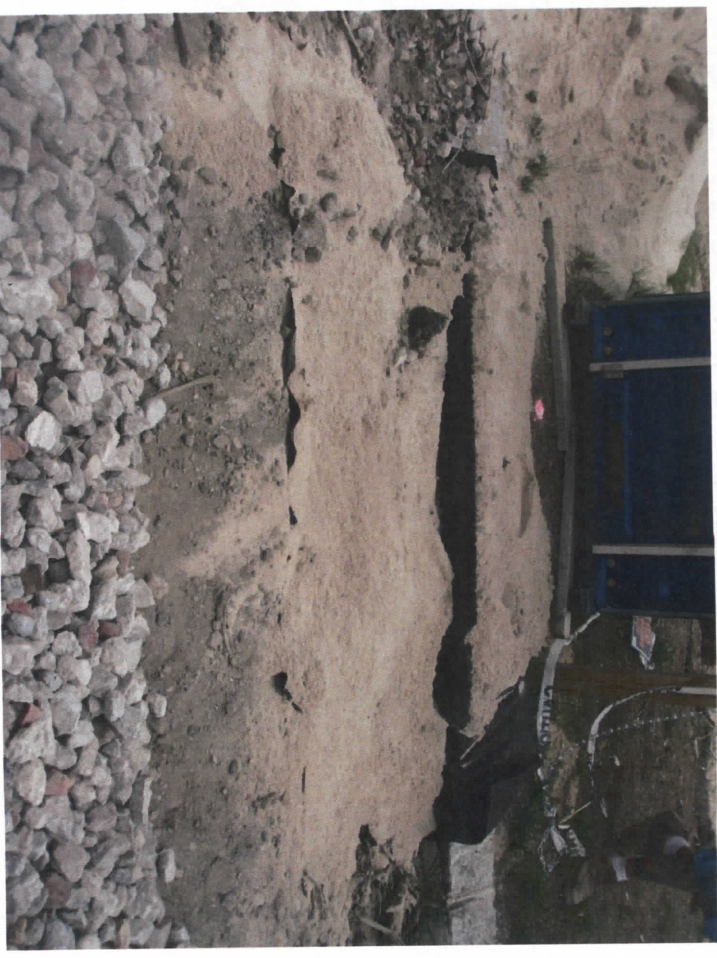
NYR10R788	Oakland Farms Construction Site	<ol style="list-style-type: none"> 1. The SMO noted that the inlet protection was not installed per plan and was covered in sand (note that there is no off site drainage at this site – inlets drain to leaching pools). 	7/8/2015

P7080005: Inlet protection at Oakland Farms construction site not installed per design plan (and covered in sand); note that inlets at this site drain to leaching pools

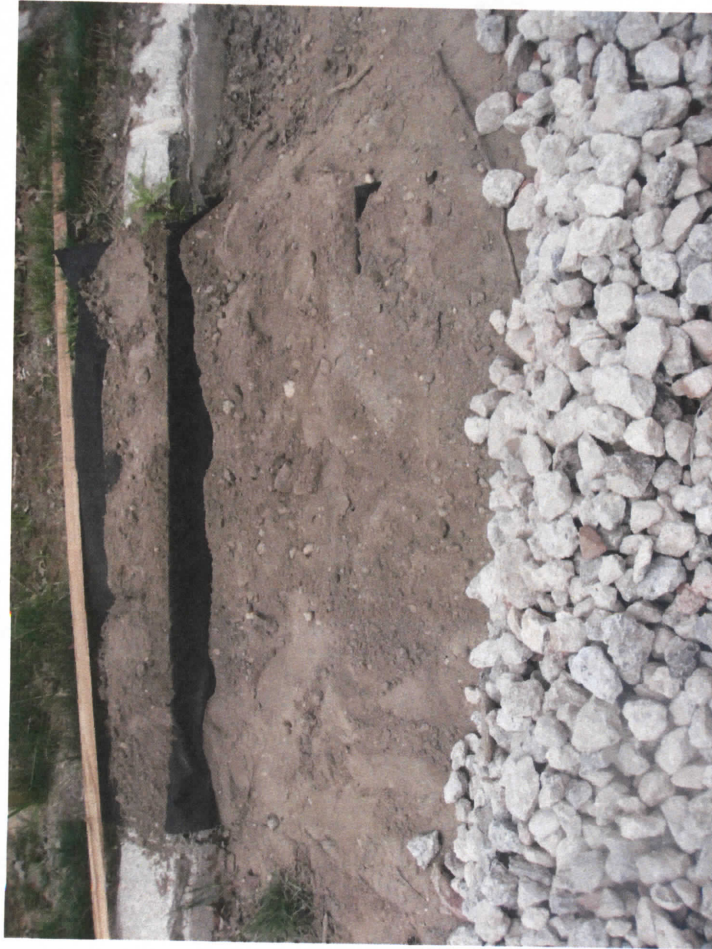
P7080006: Additional photograph of an inlet at the Oakland Farms subdivision
(protection not installed per plan and covered in sand)

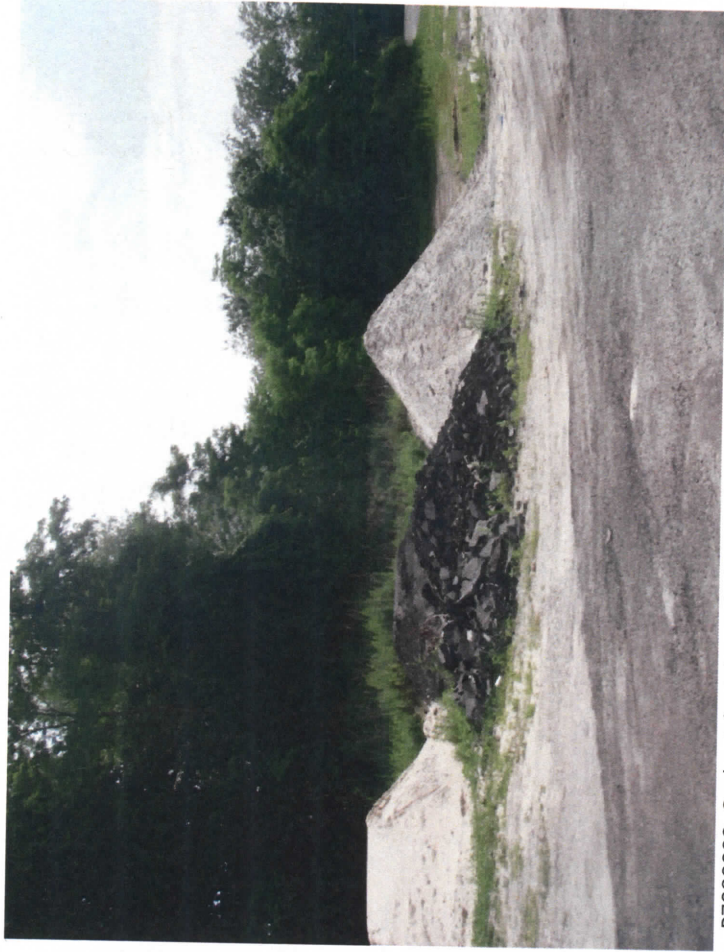
P7080008: Coal patch and recycled concrete piles at the 1524 North Sea Road Highway
Yard

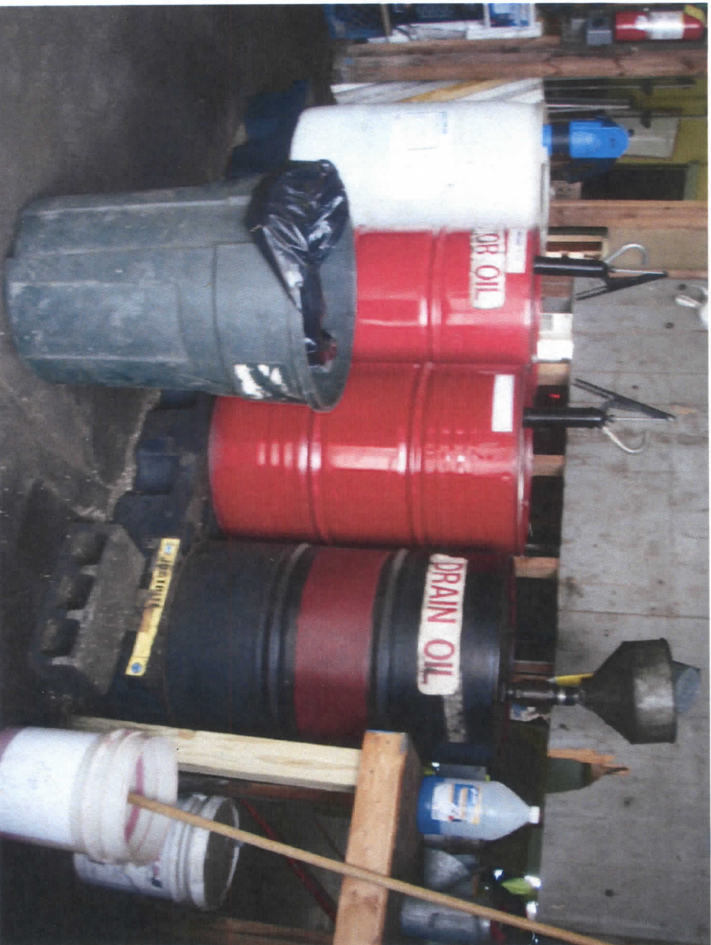
P7080013: Four (4) 55-gallon drums on spill pallets located inside the garage at the
1524 North Sea Road site

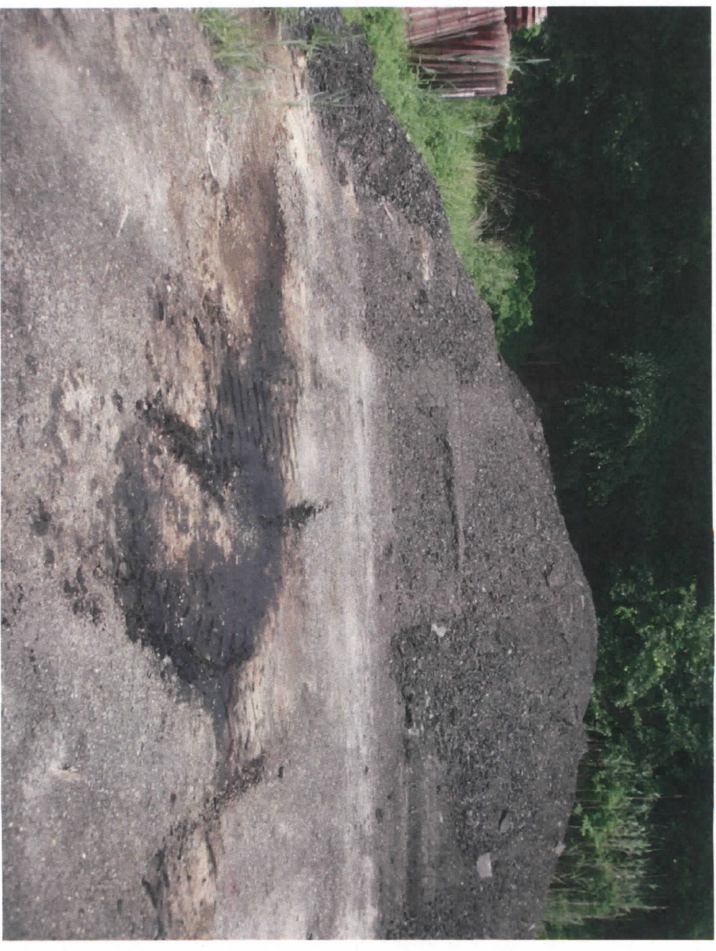
P7080016: Staining on the ground next to Recycled Asphalt Product (RAP) pile at 1524
North Sea Road

3. The following areas of concern were noted during the field portion of the Audit:
- a. Miscellaneous fuel/oil staining was observed on the ground at the 1524 North Sea Road site. Fuel/oil residues should be cleaned up in order to prevent the transport of pollutants to surface and/or ground water.

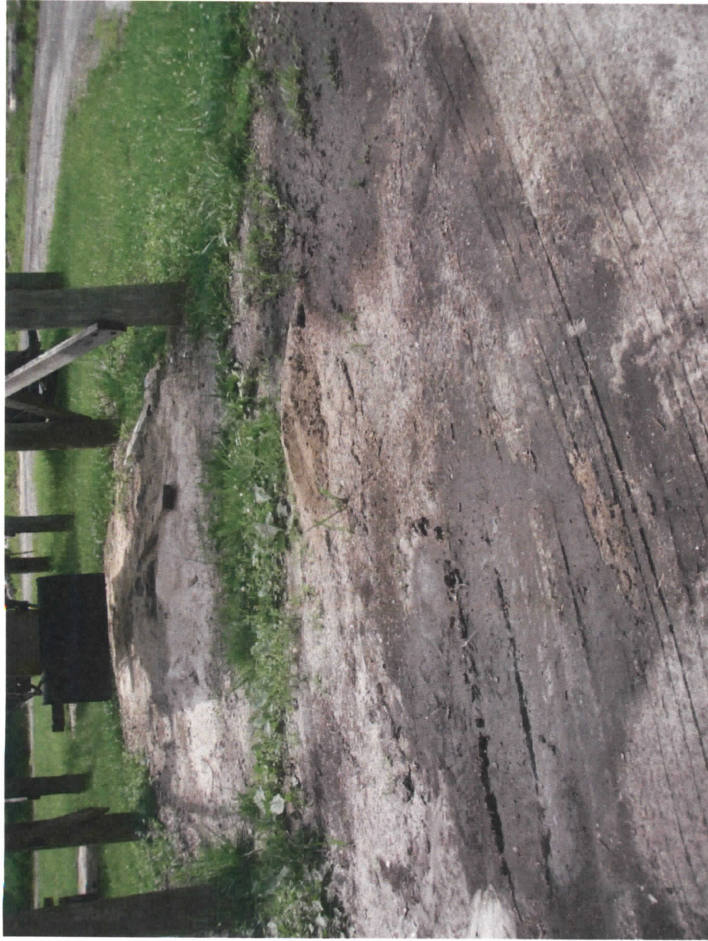
P70800018: Additional staining on the ground at 1524 North Sea Road

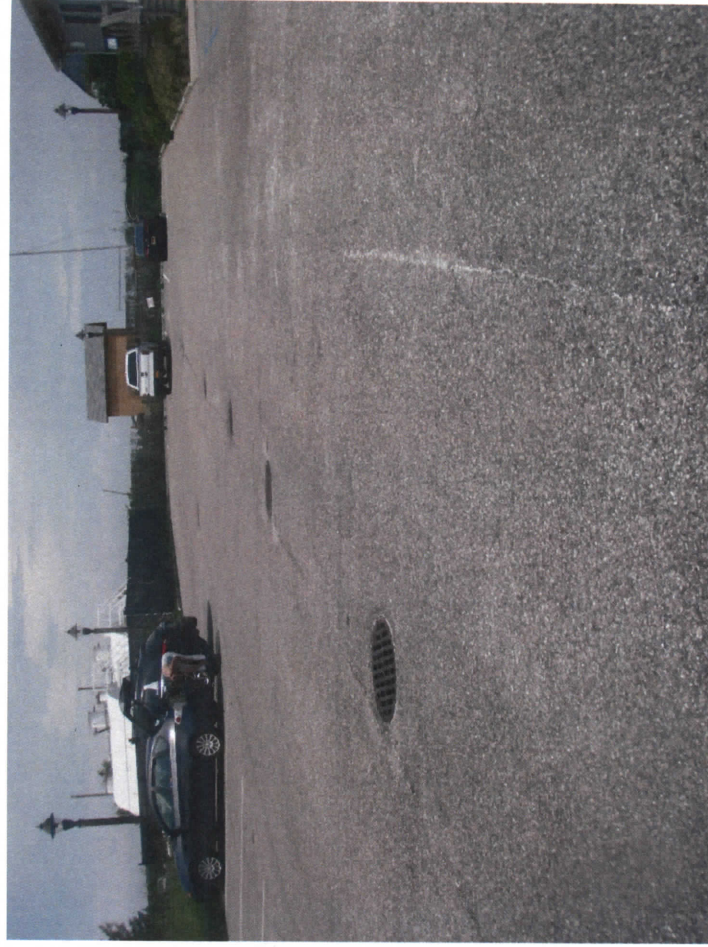
P70800021: Drains to recharge basins at Conscience Point Park; no stormwater outfalls through the bulkhead to surface water were observed.

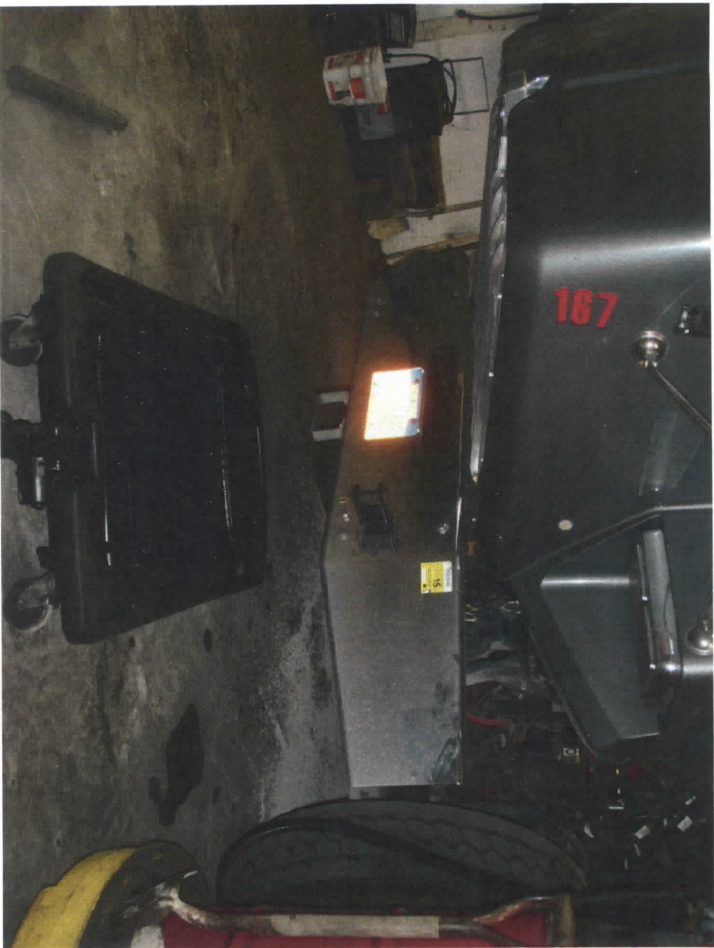
P7080024: Speedy dry in use under vehicle being maintained at the 1370 Major Path garage

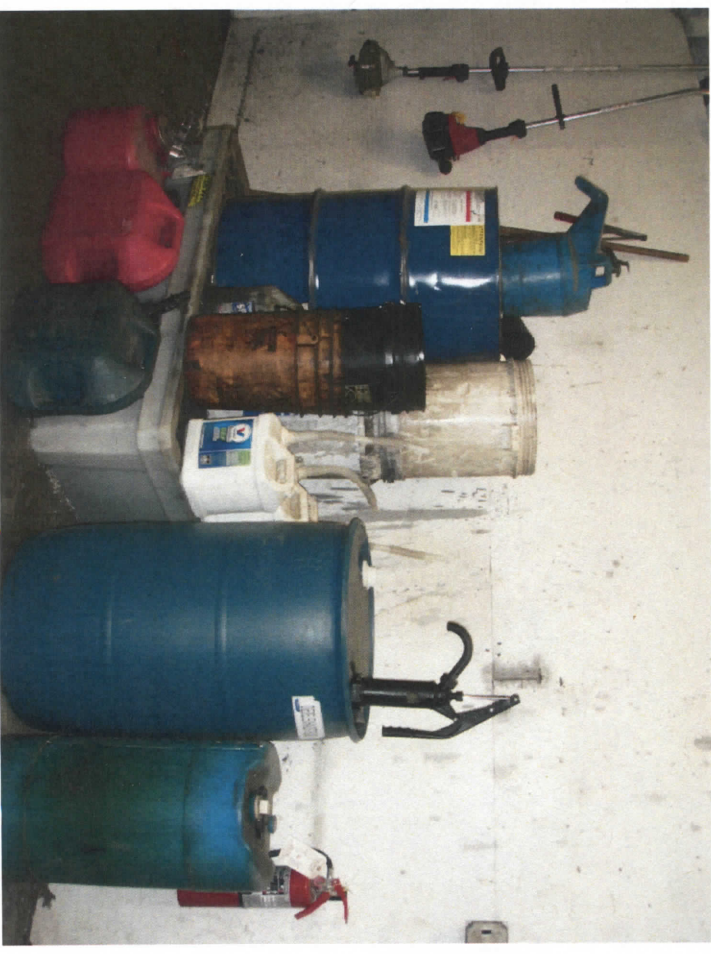
P7080025: Some petroleum products stored on spill pallet, and others (55-gallon drum and gasoline containers) stored on the floor of the garage at 1370 Major Path

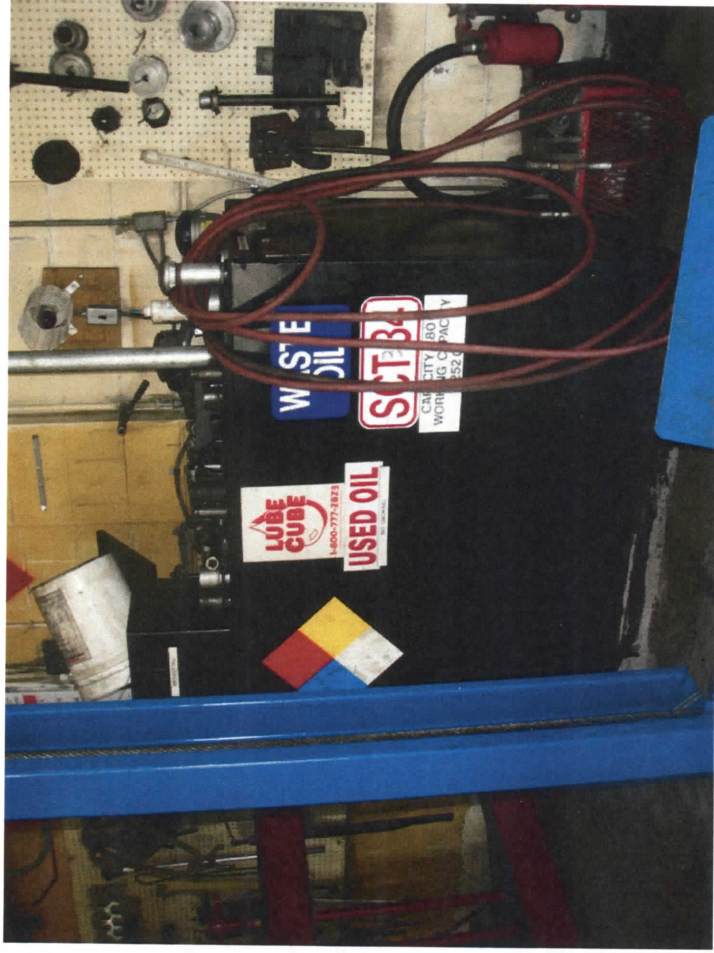
P7080033: Above ground waste oil tank inside Jackson Avenue highway garage

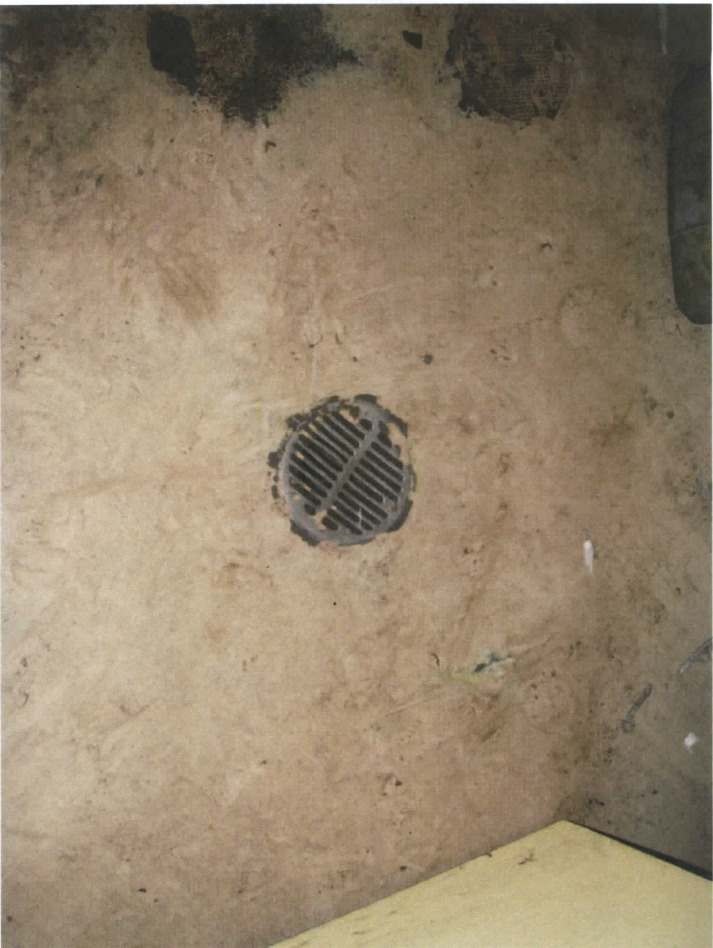
P7080038: small floor drain in shower room at the Jackson Avenue highway garage – the destination of the drain was not known, although the Highway Dept. Superintendent stated all drains had been cemented shut prior to his arrival

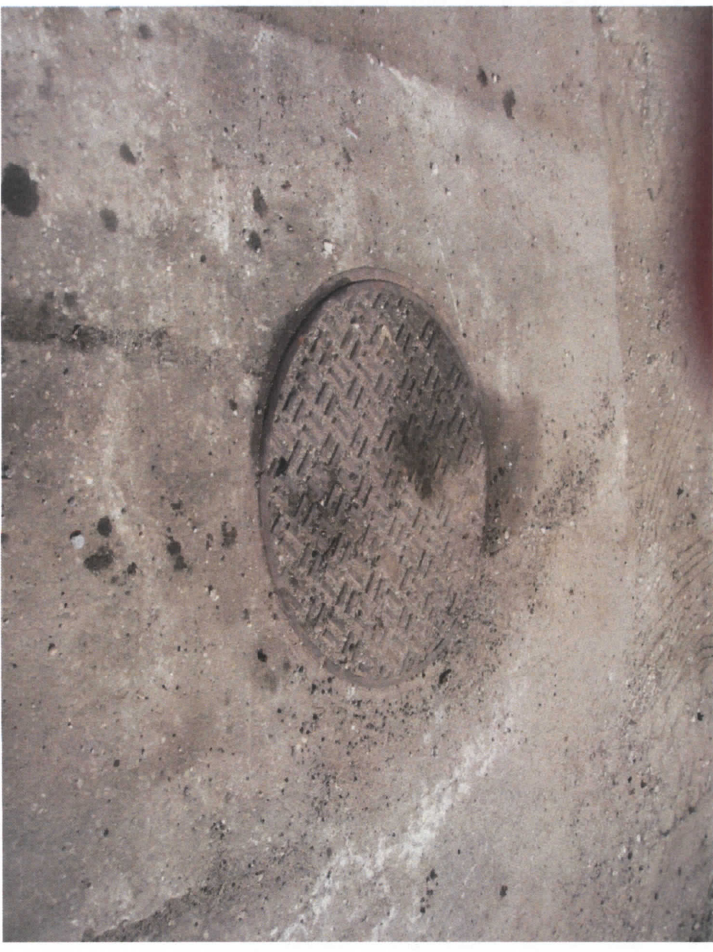
P7080040: minor staining on ground / manhole cover outside the Jackson Avenue highway garage

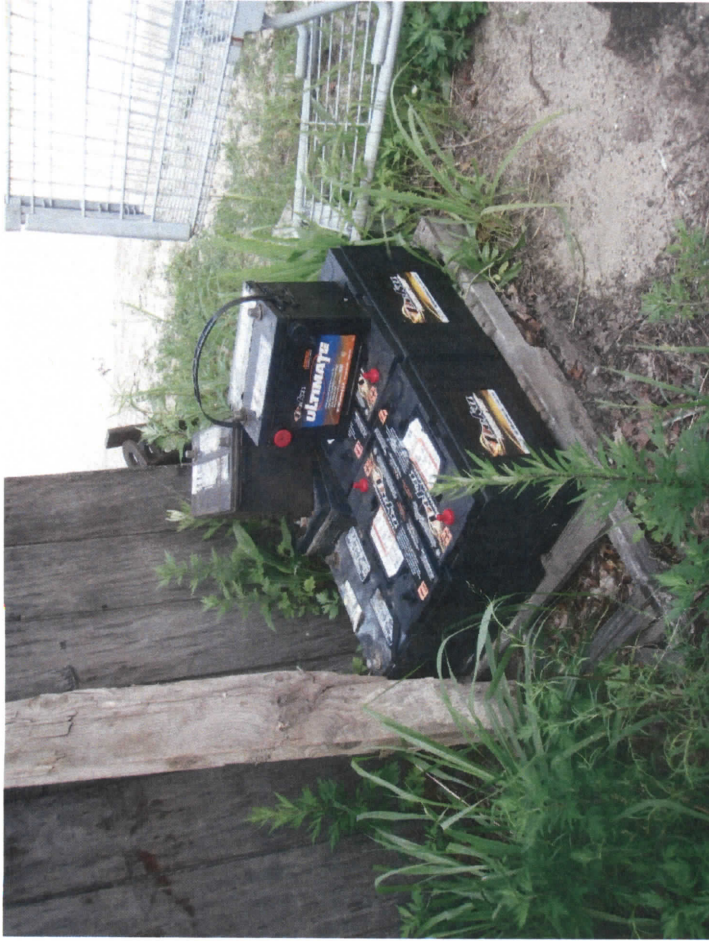
P7080043: Batteries identified outside the Jackson Avenue highway garage

- e. Batteries were observed on the ground outside the highway garage at 20 Jackson Avenue. Batteries should be stored in a location where they are not exposed to stormwater.

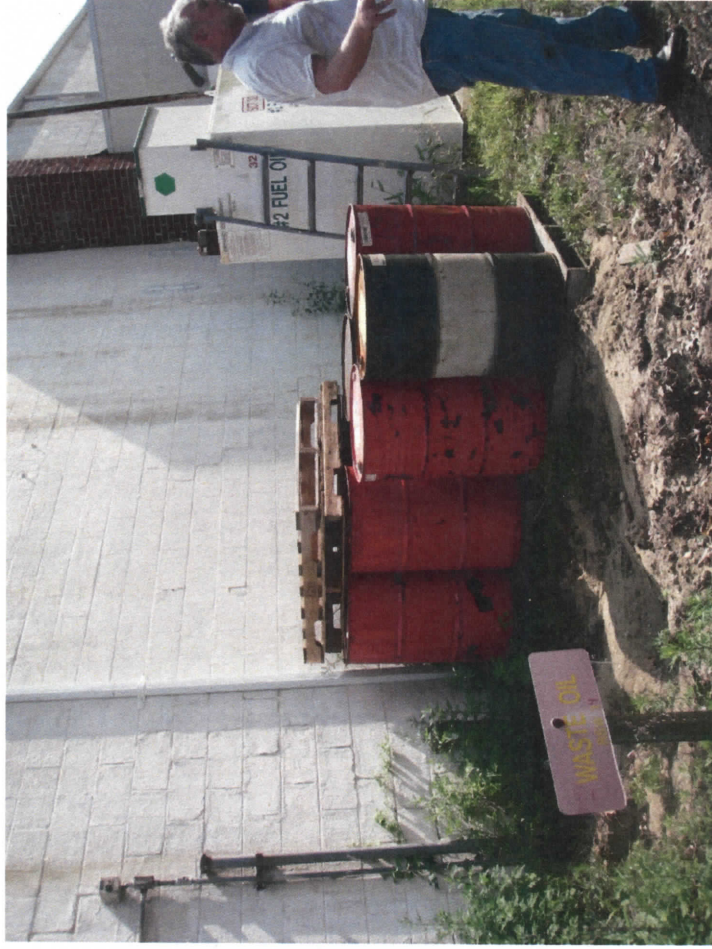
P7080046: 900-gallon #2 heating oil tank outside of the Jackson Avenue highway garage (background). 55-gallon drums on wooden pallets with unknown contents (foreground).

- f. One (1) drywell was observed outside the 20 Jackson Avenue facility. Storage in the vicinity of the drywell included a 900-gallon #2 heating oil tank, and 55-gallon drums stored on wooden pallets. The contents of the 55-gallon drums were not identified at the time of the Audit. Please confirm.

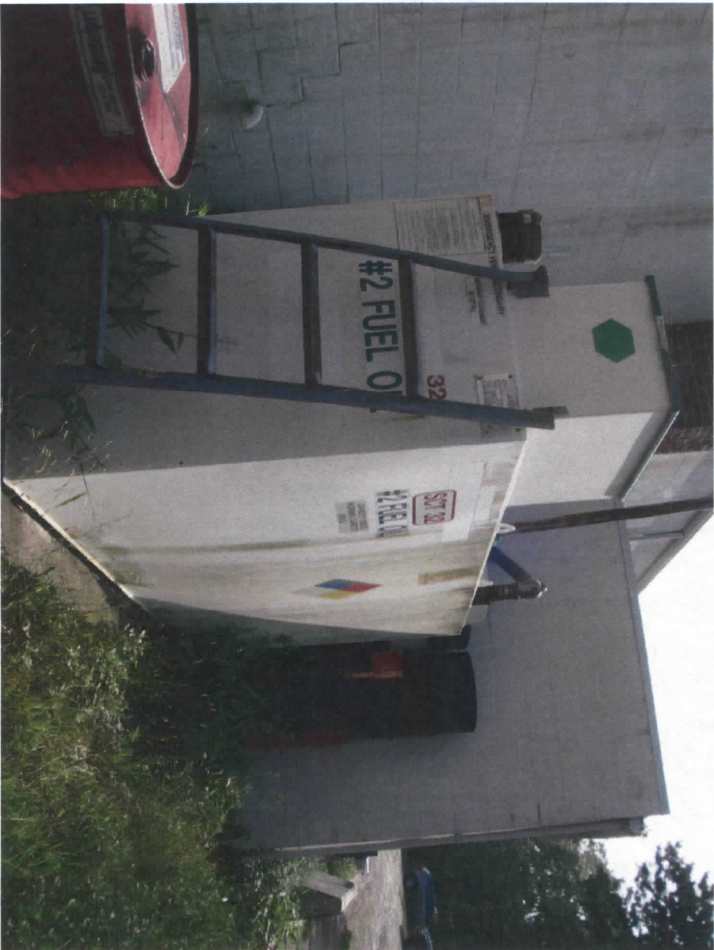
P7080047: 900-gallon #2 heating oil tank

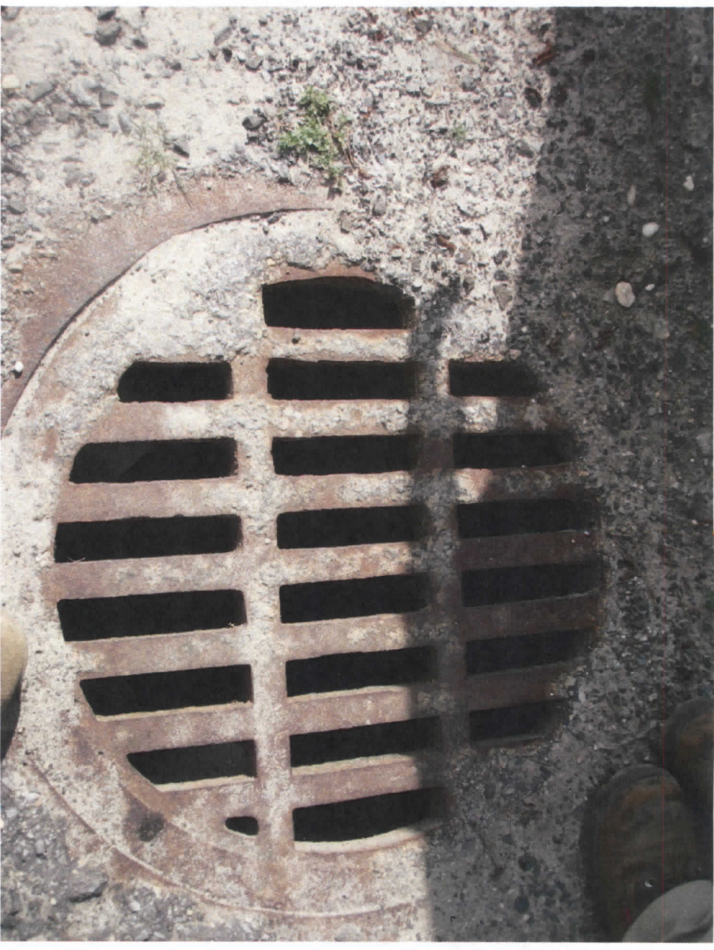
P7080048: only drywell observed at the Jackson Avenue highway yard on the north side of the highway garage (near #2 heating oil tank)

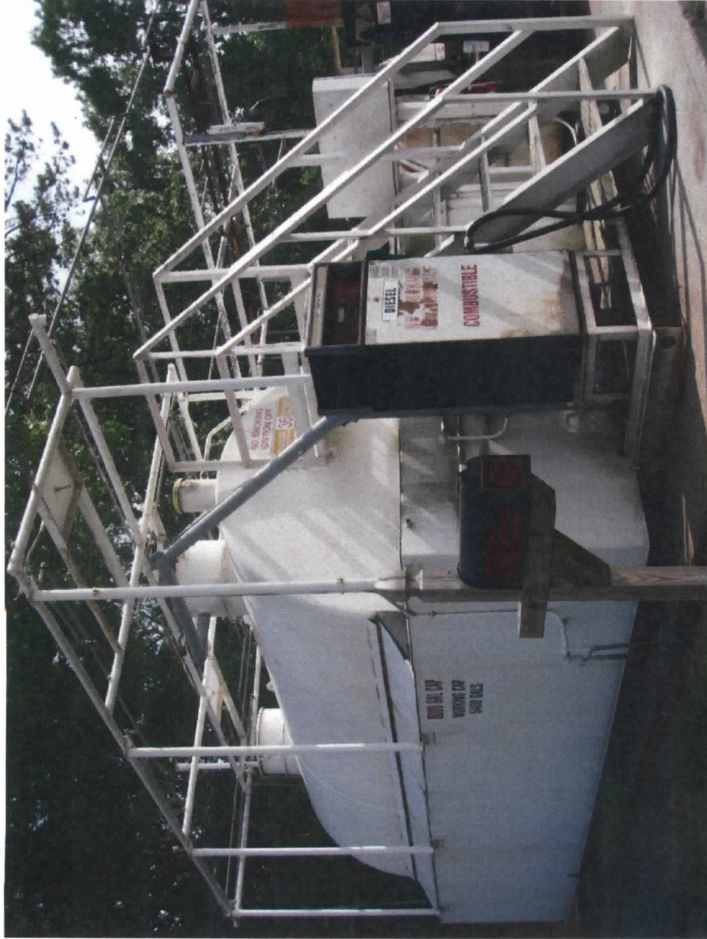
P7080051: Aboveground 6000-gallon diesel and 1000-gallon gasoline tanks at the Jackson Avenue Highway Yard

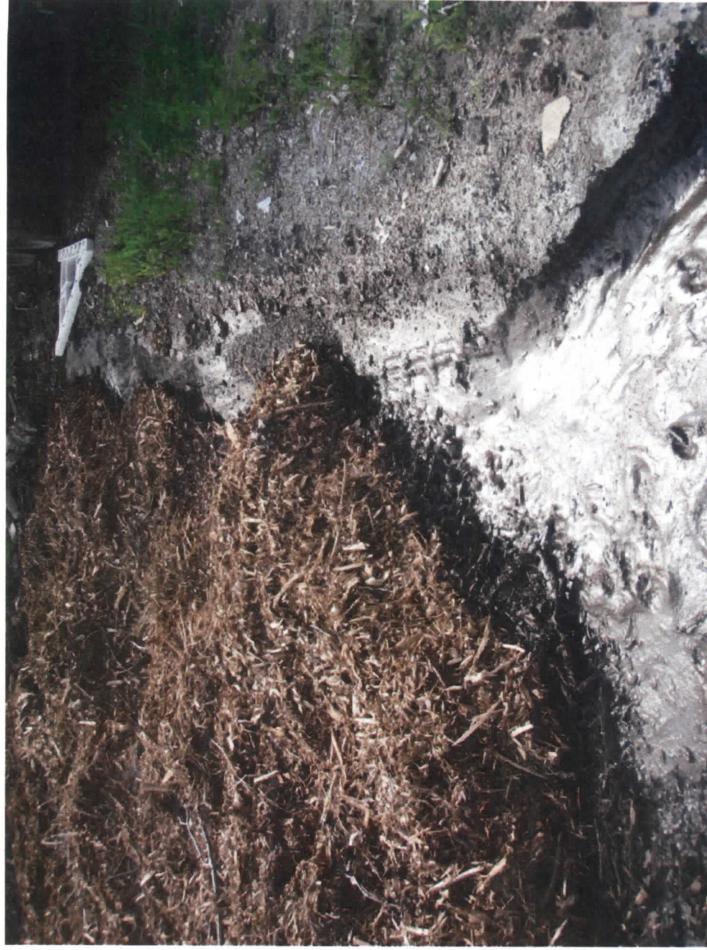
P7080063: silt and sediment from sweeper washout pushed to the west side of the Jackson Avenue highway yard. Mulch appeared to have been recently applied to this area.

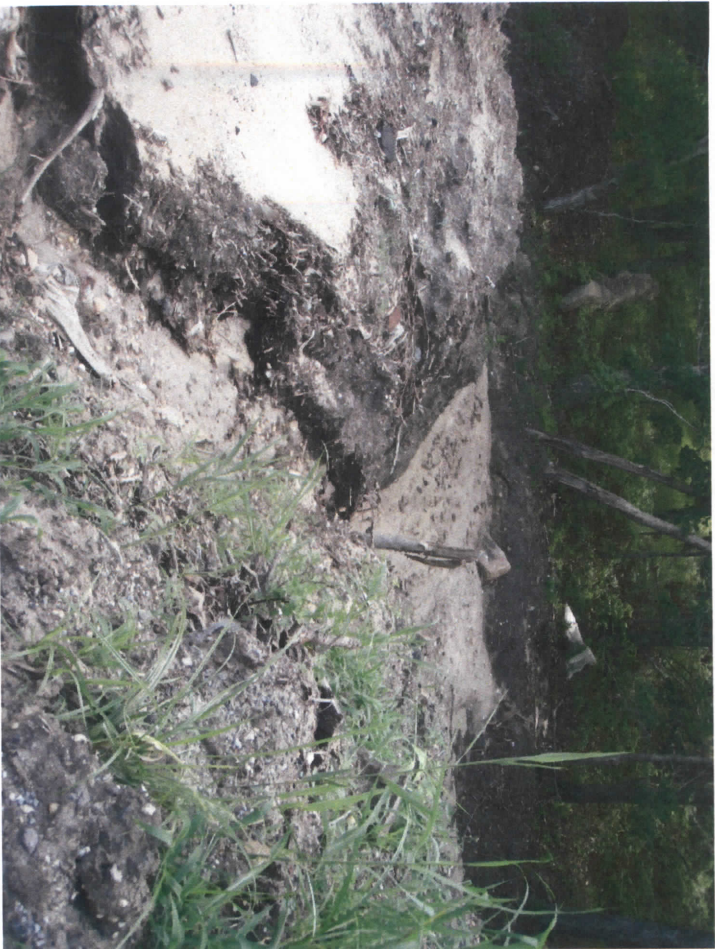
P7080064: Accumulated silt and sediment debris from sweeper washout on the west side of the Jackson Avenue highway yard (west side)

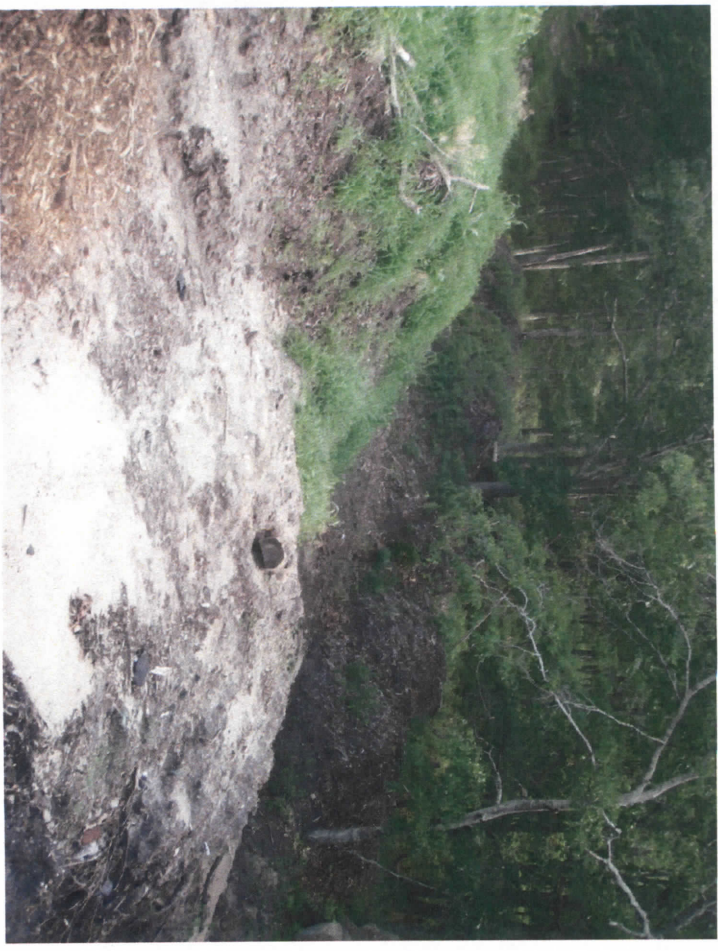
P7080065: Accumulated silt and sediment debris from sweeper washout on the west side of the Site.

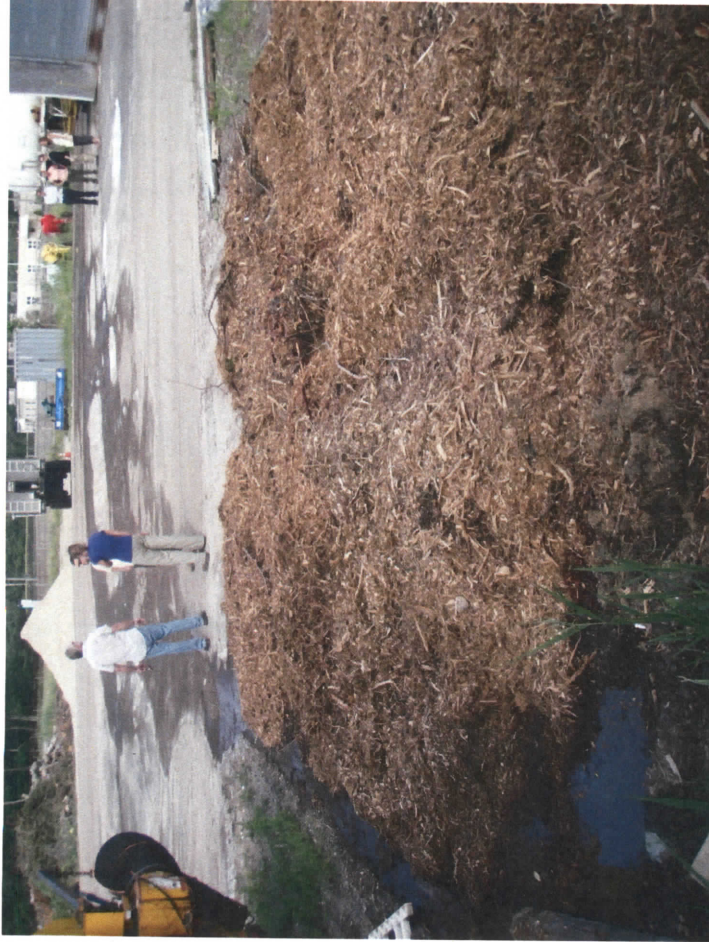
P7080069: Mulched area of the western side of the Jackson Avenue highway yard (also identified in photograph P7080063) looking back towards center of the yard where sweepers are washed out.

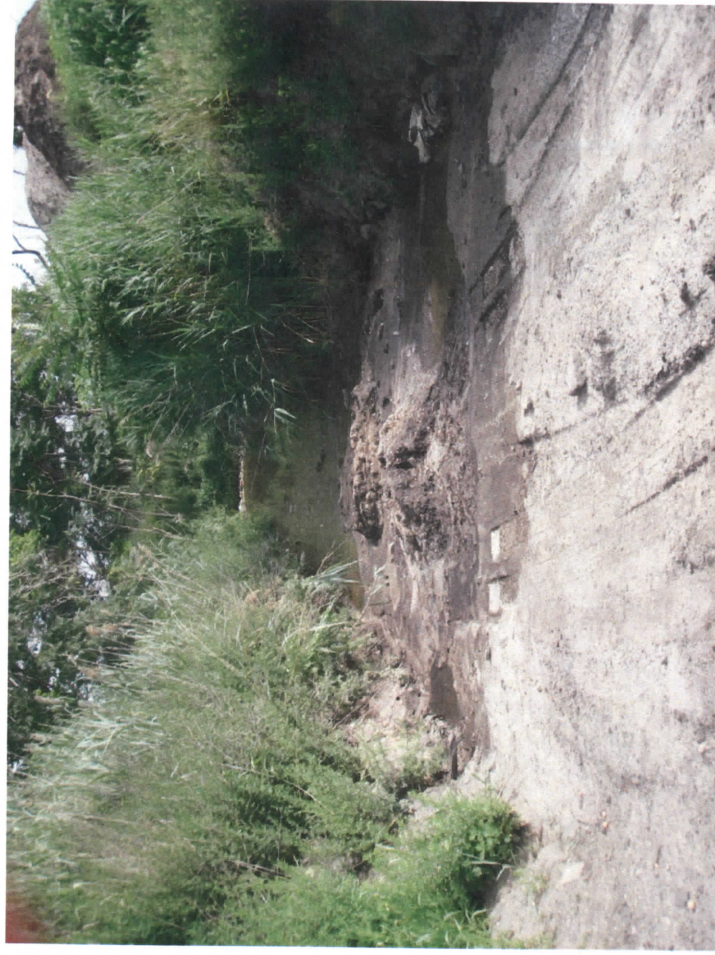
P7080073: "Lagoon" at Jackson Avenue Highway Yard used to deposit wet material removed from catch basins

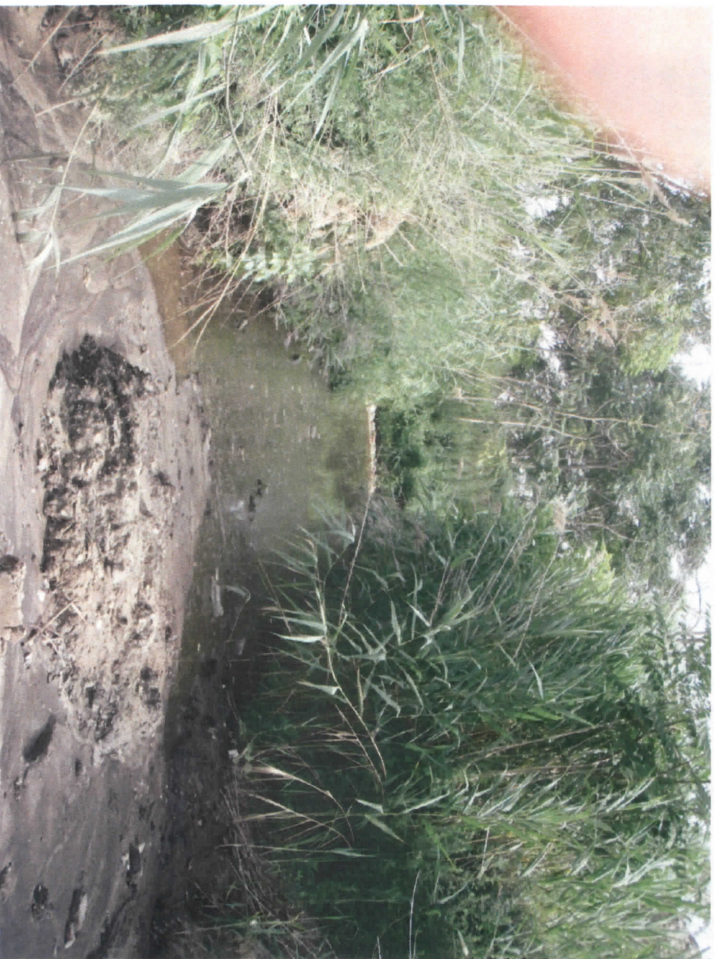
P7080074: Close-up of silt and sediment accumulation in lagoon used to deposit wet catch basin contents

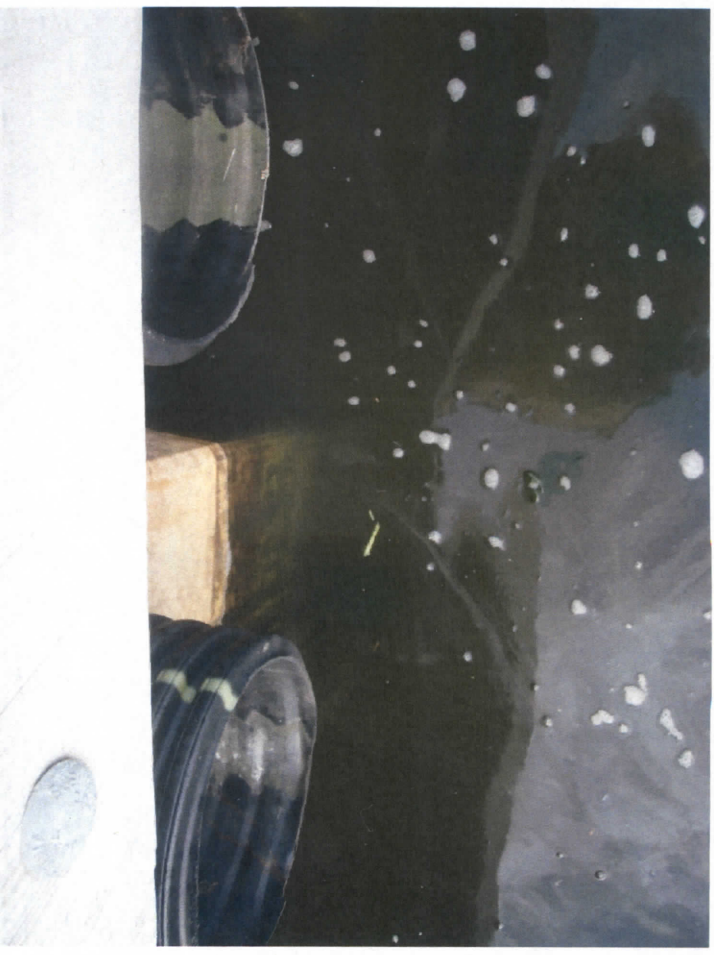
P7090077: Outfall 1 (outfall data sheet indicates that there are 2 12" HDPE pipes here – both pipes may drain same drainage structure, but this is unclear). No flow at time of field visit.

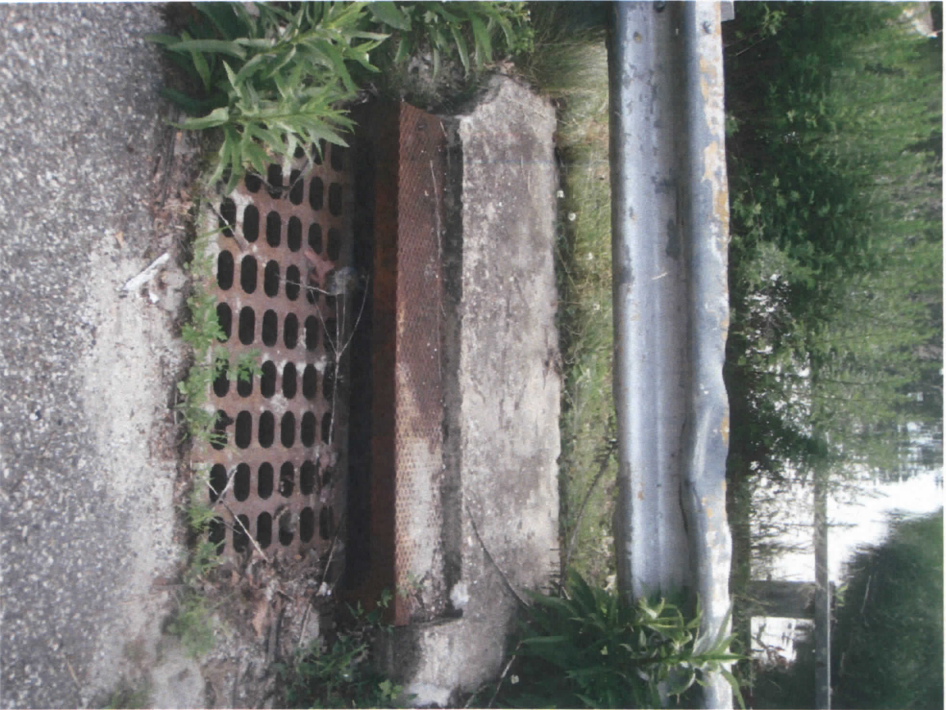
P7090084: Catch basin upstream of Outfall 4

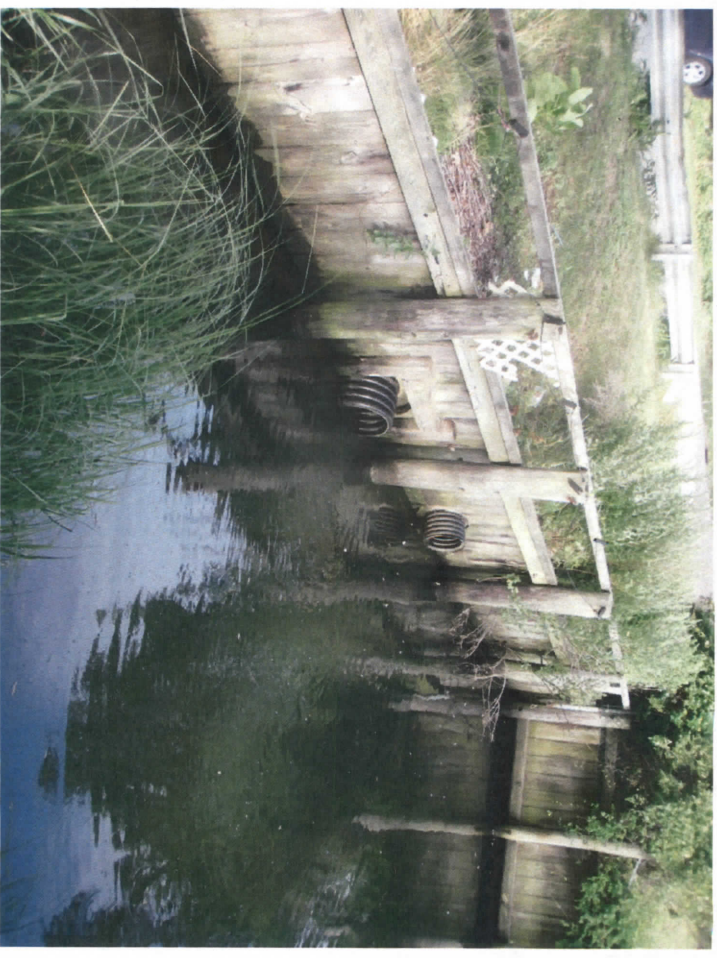
Mapped Outfall	Outfall 4	1. One 12" HDPE pipe with connection to catch basin in street (Dam Trail). No flow was identified from the outfall. Sediment and leafy debris were observed in the catch basin at the time of the field visit. Pipe discharges to Reeves Bay trib. Culvert pipe draining pond to the south of the outfall (flowing).	7/9/2015
Mapped Outfall	Outfall 38	1. This outfall appears to be a blind connection somewhere between an inlet on Oak Drive and a pipe conveying Silverbrook pond to the north side of SR-24. Flowing, but no indicators of illicit discharges.	7/9/2015
Mapped Outfall	Outfall 2	1. Short 12" CMP conveying roadside drainage to brook. No flow identified at the time of the field visit. There is a 24" CMP next to this outfall that appears to be a culvert pipe.	7/9/2015
Mapped Outfall	Outfall 3	1. A 24" CMP was identified in accordance with the outfall data sheet; however, an upstream drainage structure	7/9/2015

P7090088: Outfall 4 on right (no flow), culvert under Dam Trail on left (tidal, flowing)

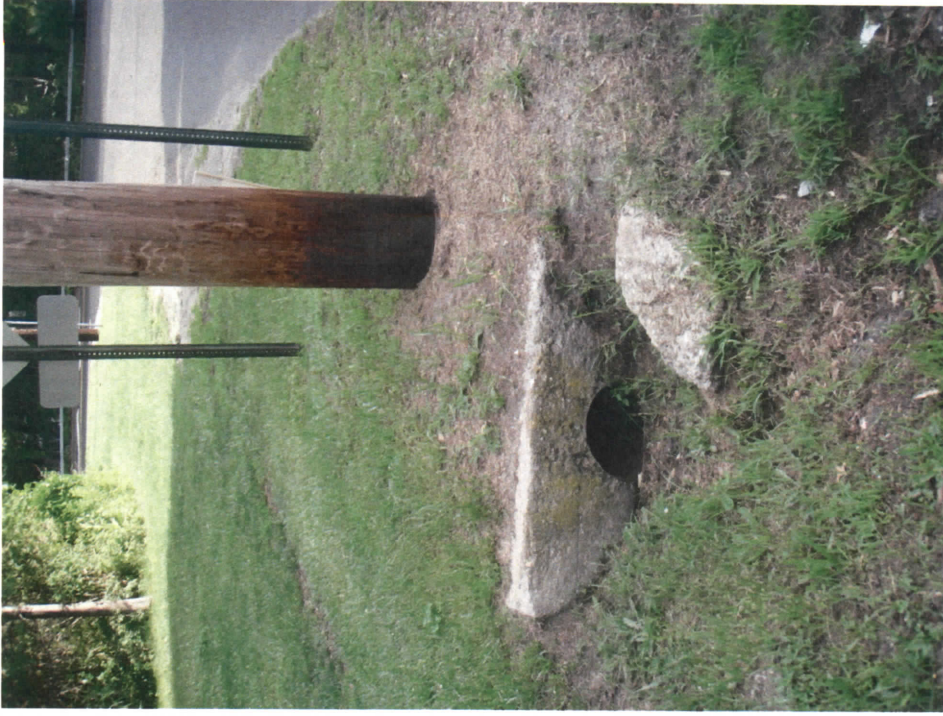
P7090091: Inlet on Oak Drive believed to have blind connection to Outfall 38 across SR-24

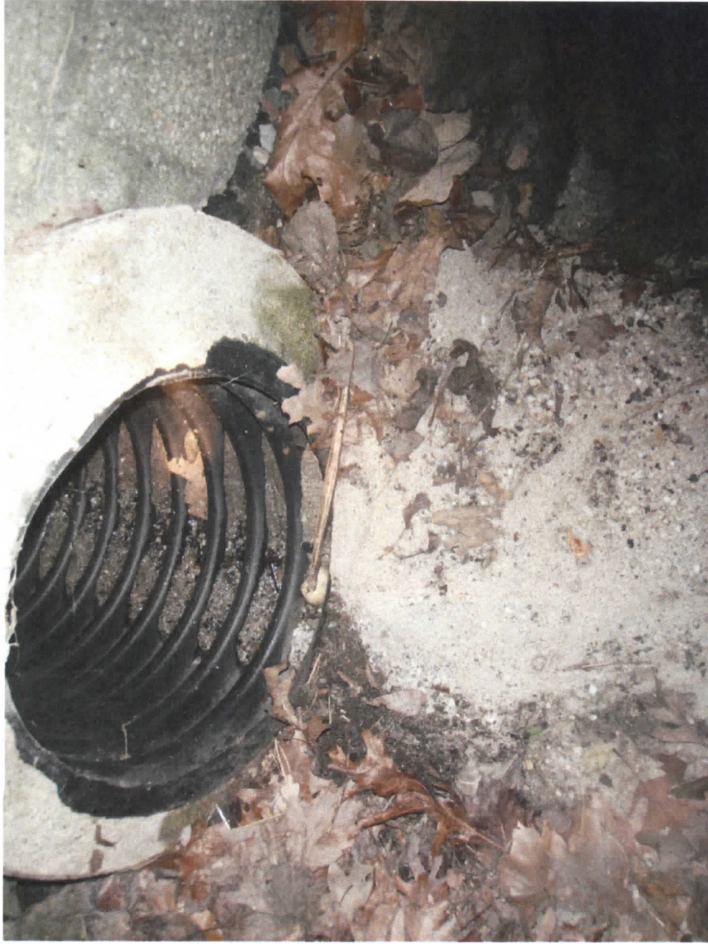
P7090090: Sediment and leafy debris inside catch basin leading to Outfall 4

- j. At Outfall 4, sediment and leafy debris were observed in the upstream catch basin at the time of the field visit.
